# Transformer Rupture Statistics

**EPRI Report 3212-1**

**March 21, 2006**

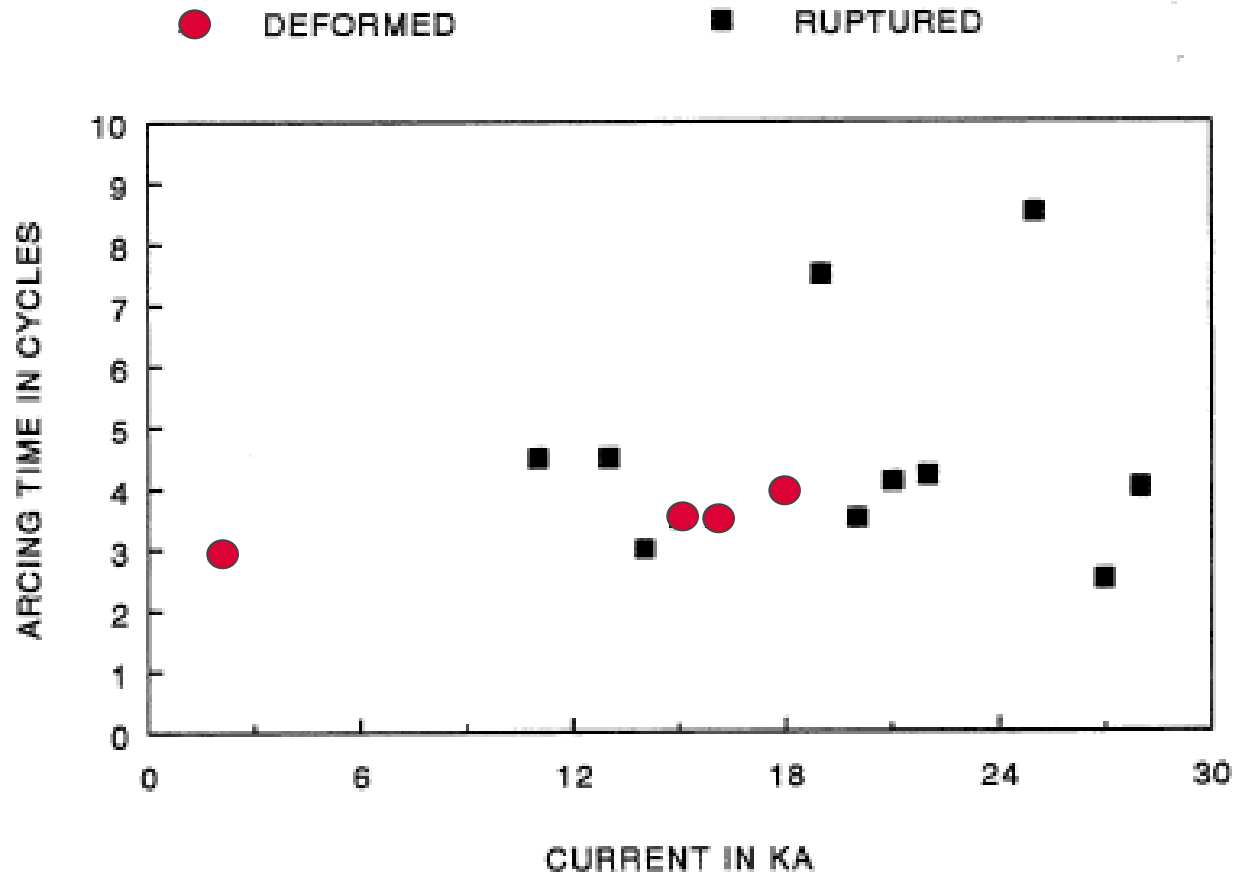
# Arcing time vs. Fault Currents

Deformations occurred with arcing times up to 4.0 cycles and all cases with longer times ruptured, including three GSU transformers not listed above that had arcing times in the ‘seconds’ time frame.

It is significant that ten ruptures occurred with arcing times in the range of **3.5 to 4.5 cycles**.
