INTRODUCING MODERN TRANSFORMER ISOLATION BARRIER

IEEE Transformer Rupture Mitigation Task Group Presentation:

An Overview of Proposed new Requirements for Transformer Isolation Barriers for hazard containment

Proposed IEEE Specification for Transformer Isolation Barriers

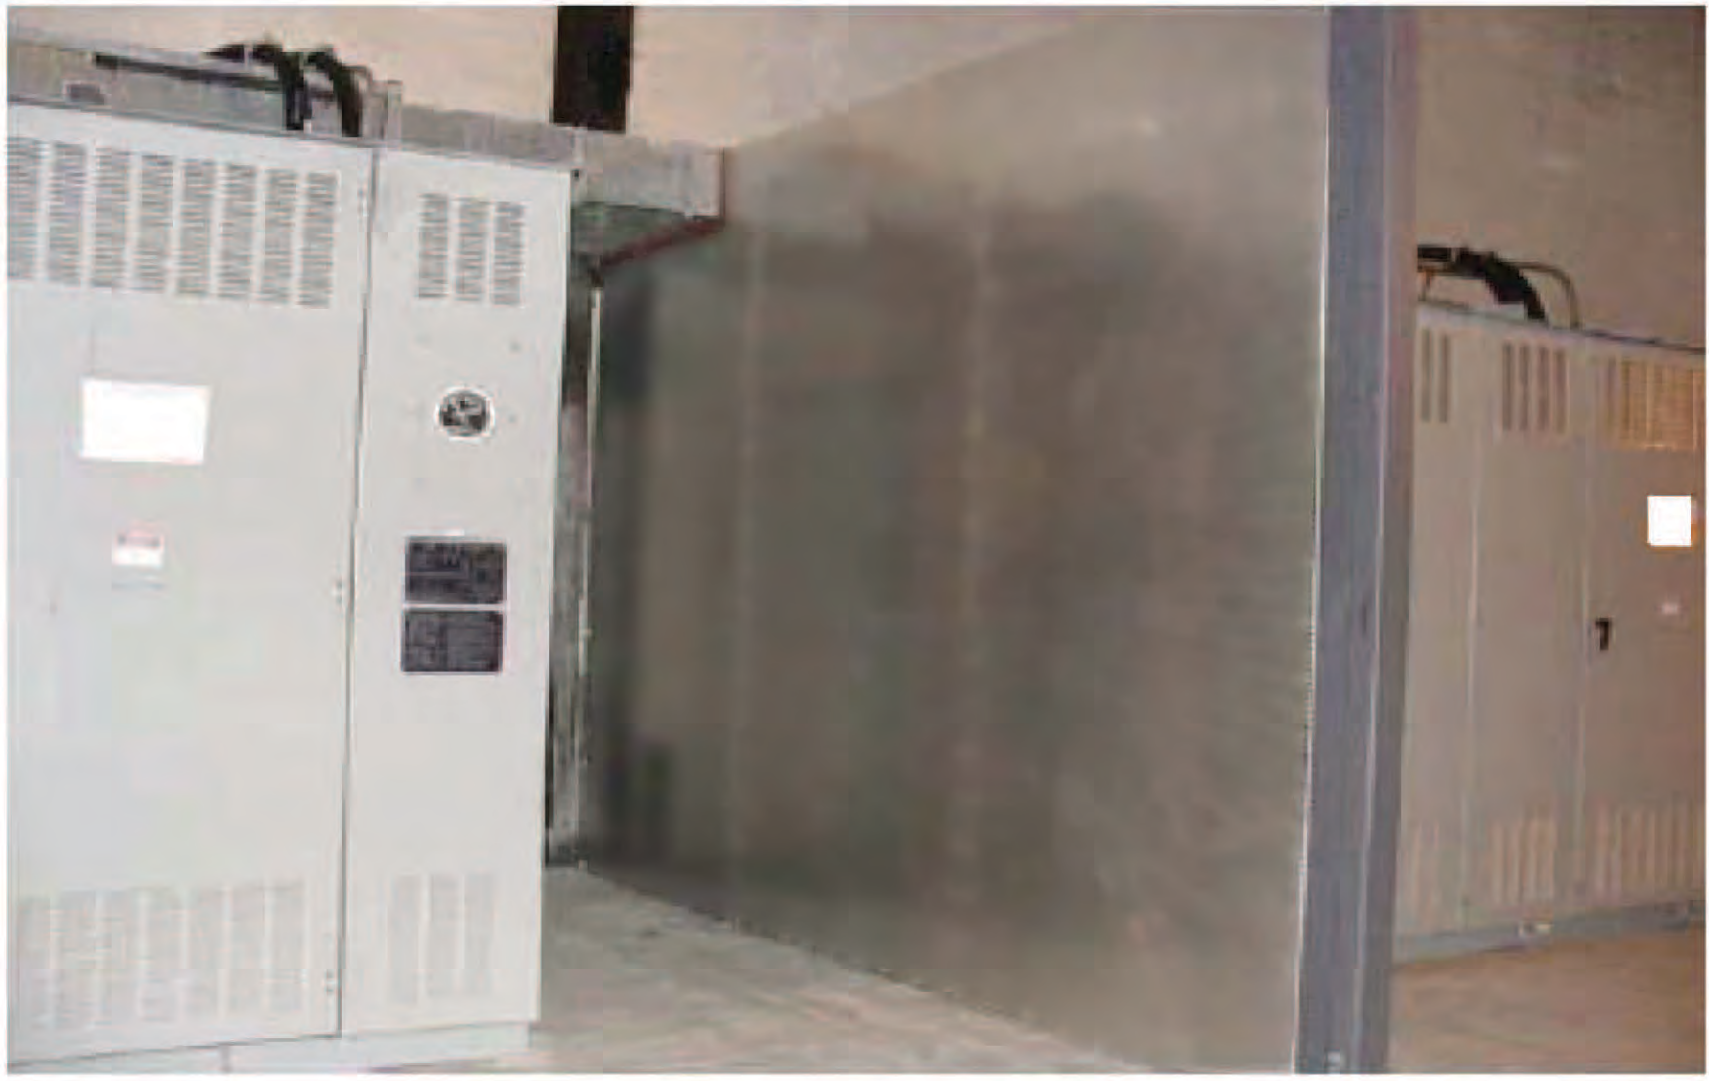
Barrier Between AC/DC Transformers & Cable Tray
