**LARGE PRESSURE RELIEF  
DEVICES (PRDs) AND THEIR USE  
ON POWER AND DISTRIBUTION  
TRANSFORMERS AND RELATED  
EQUIPMENT**

TF - Tank Rupture and Mitigation -  
March 2006 J.Herz

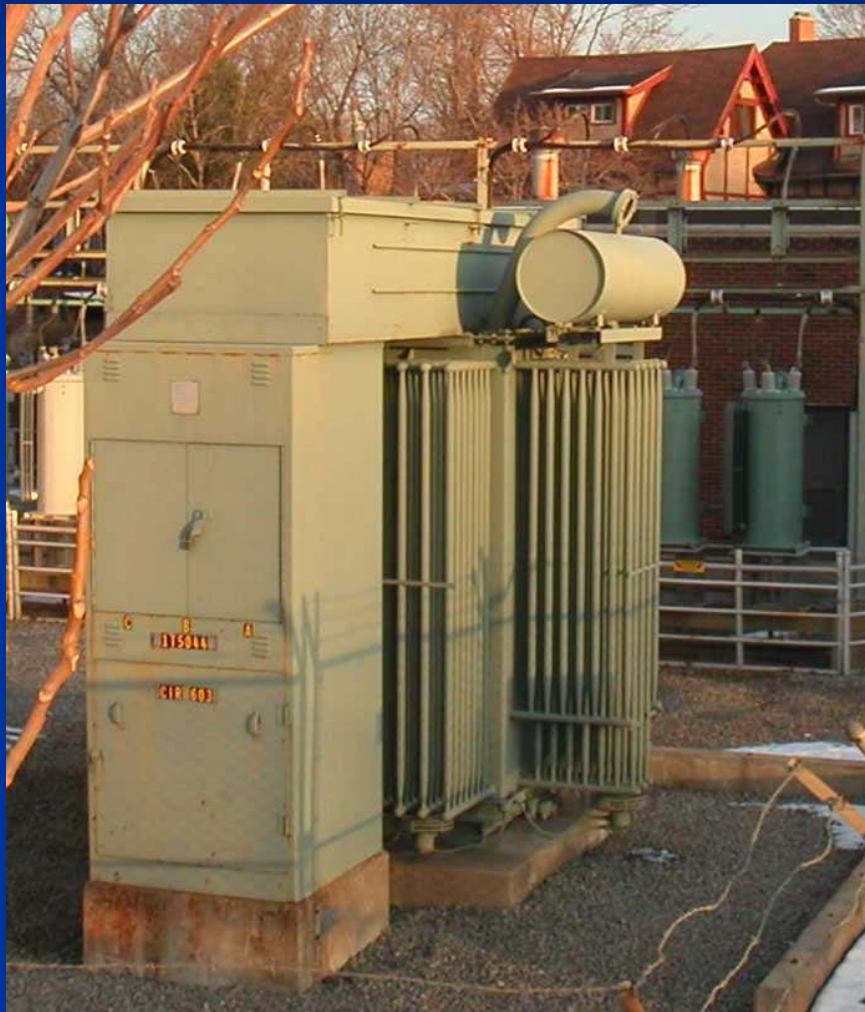
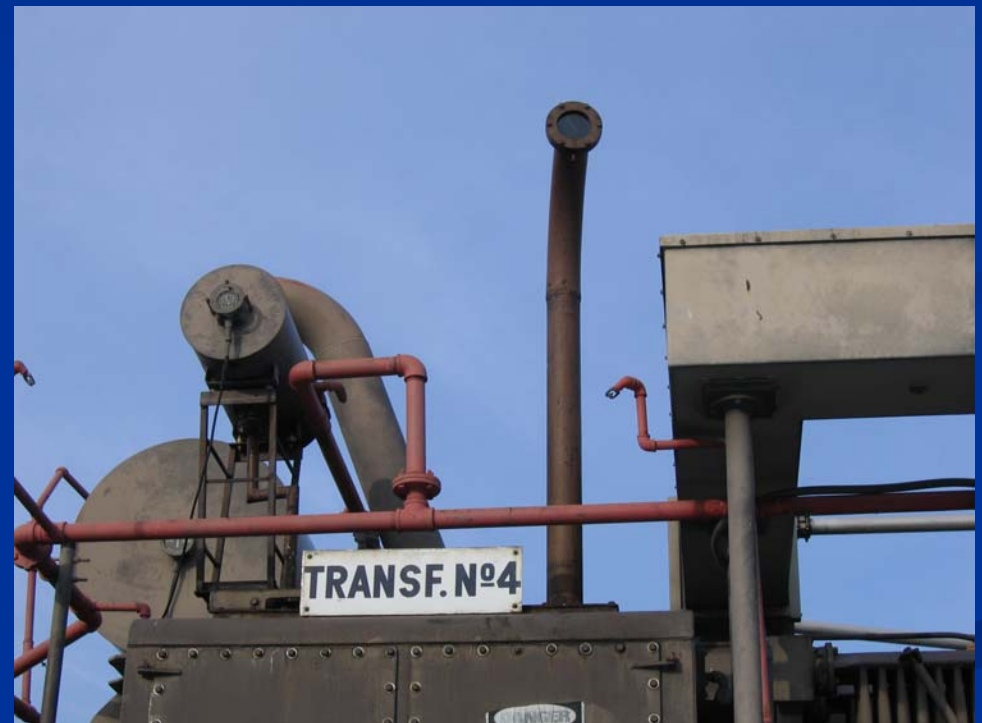
# Rupture Discs

- HAD TO BE REPLACED AFTER OPERATION
- LEFT THE TRANSFORMER OPEN TO ATMOSPHERIC MOISTURE IN THE INTERIM

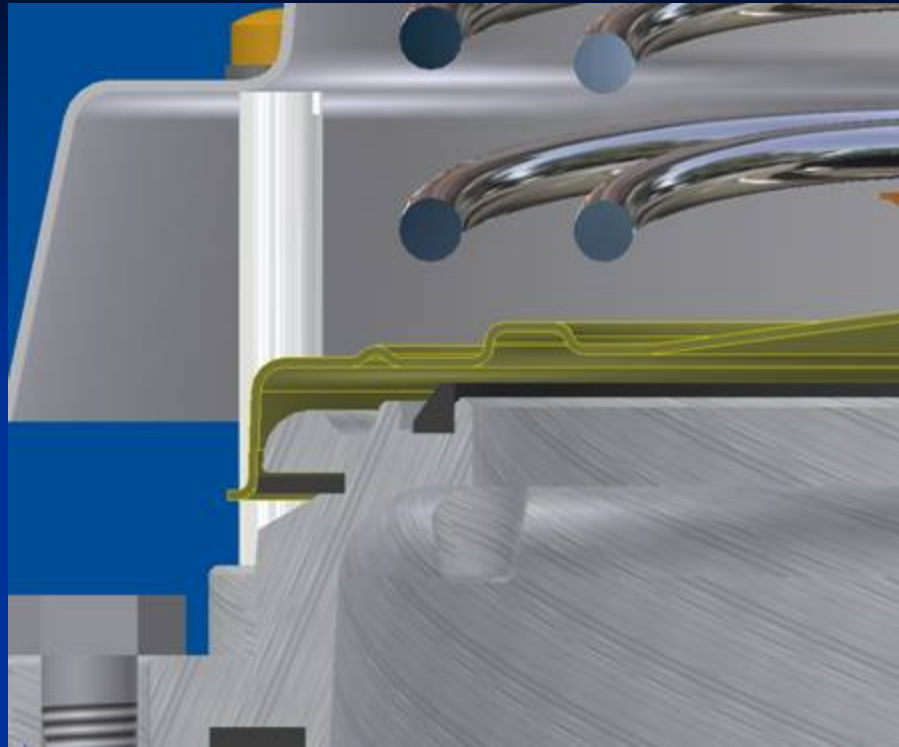
WHEN OPERATING PRESSURE IS REACHED, TOP SEAL OPENS WHILE SIDE SEAL REMAINS BRIEFLY CLOSED

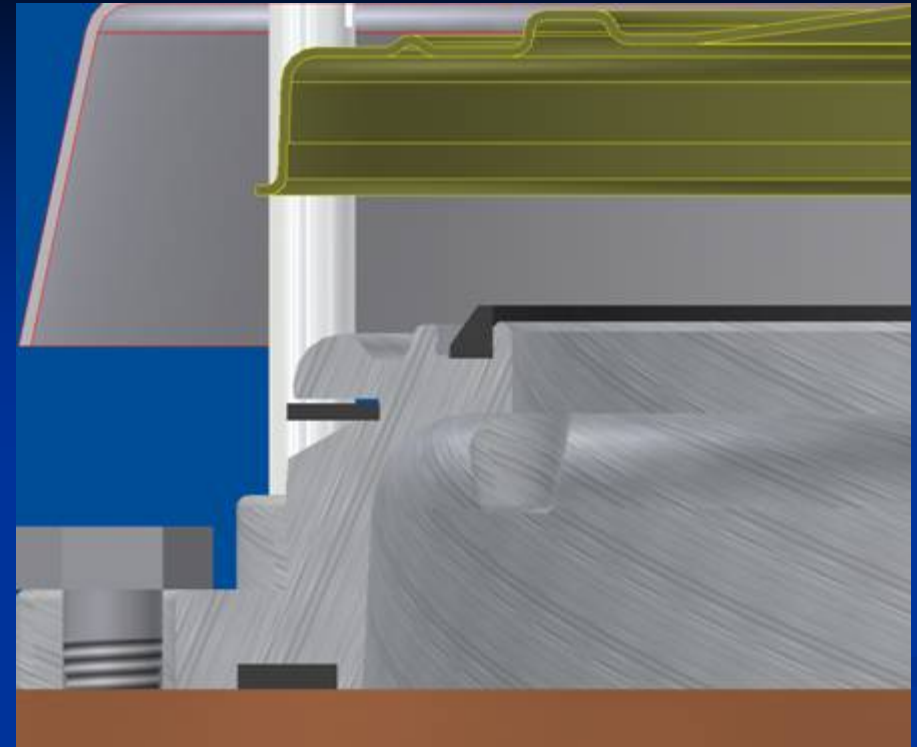
WITH OPERATING PRESSURE ACTING ON THE LARGER AREA CIRCUMSCRIBED BY THE SIDE SEAL, THE SPRING IS RAPIDLY COMPRESSED AND THE VALVE EXHAUSTS QUICKLY

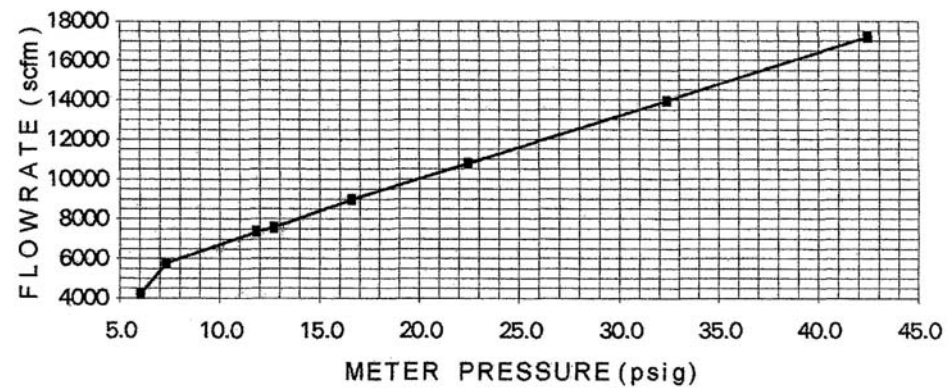
**FLOW CURVE**

PRESSURE PSIG	AIRFLOW SCFM
6.092	4215
7.338	5756
11.826	7359
12.074	7551
16.601	8979
22.478	10771
32.389	13930
42.451	17174

8400 SCFM AT 50% OVERPRESSURE ON A 10 PSI PRD WAS TYPICAL. NOW THERE ARE DEVICES WHICH GO TO 12,600 SCFM.
